NASA/TM-2001-210846

Structural Testing of a Stitched / Resin Film Infused Graphite-Epoxy Wing Box

*Dawn C. Jegley and Harold G. Bush
Langley Research Center, Hampton, Virginia*

April 2001

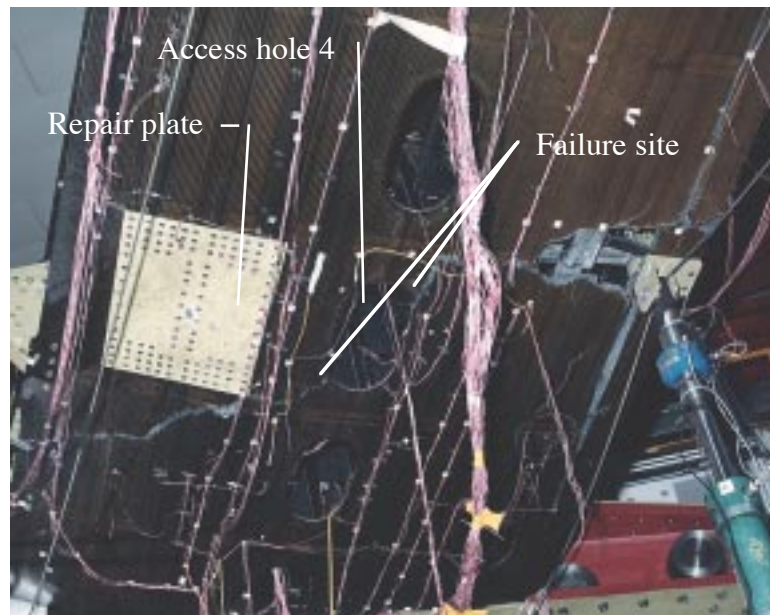
The test article supported 97% of its Design Ultimate Load (DUL) prior to failure. This load corresponds to the actuator load values shown in figure 46. A photograph of the test article loaded at 95% DUL is shown in figure 44. The primary failure location is across the lower cover panel through access hole 4. This region of the lower cover panel after final failure is shown in figure 75. The failure goes through all stringers but primarily remains between ribs 8 and 9. Both spars were also damaged, as shown in figures 76 and 77. Other minor damage was found but appears to be unrelated to the initial failure event. The discussion of the failure will be limited to the regions between ribs 6 and 10, the impact sites and the repairs.

Figure 75. Failure across lower cover panel.

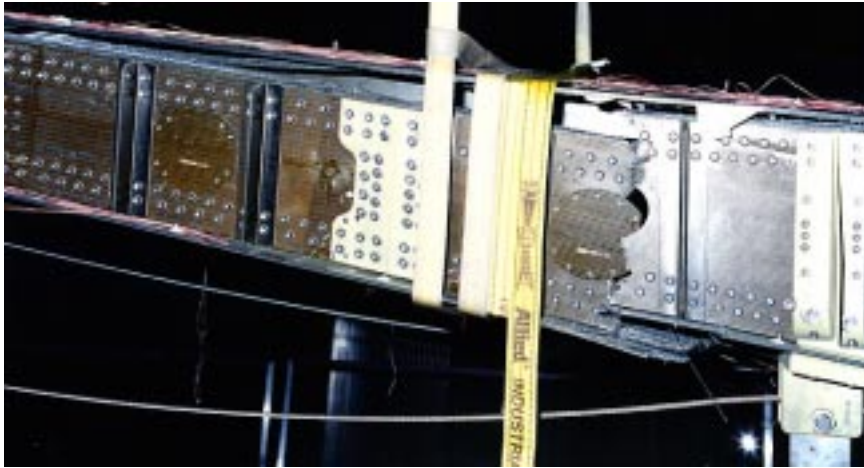
Figure 76. Rear spar after final test.

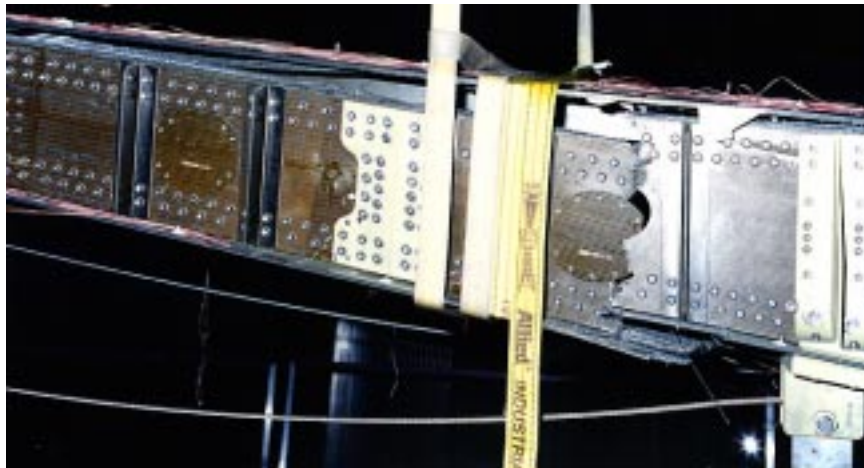
Figure 77. Front spar after final test.

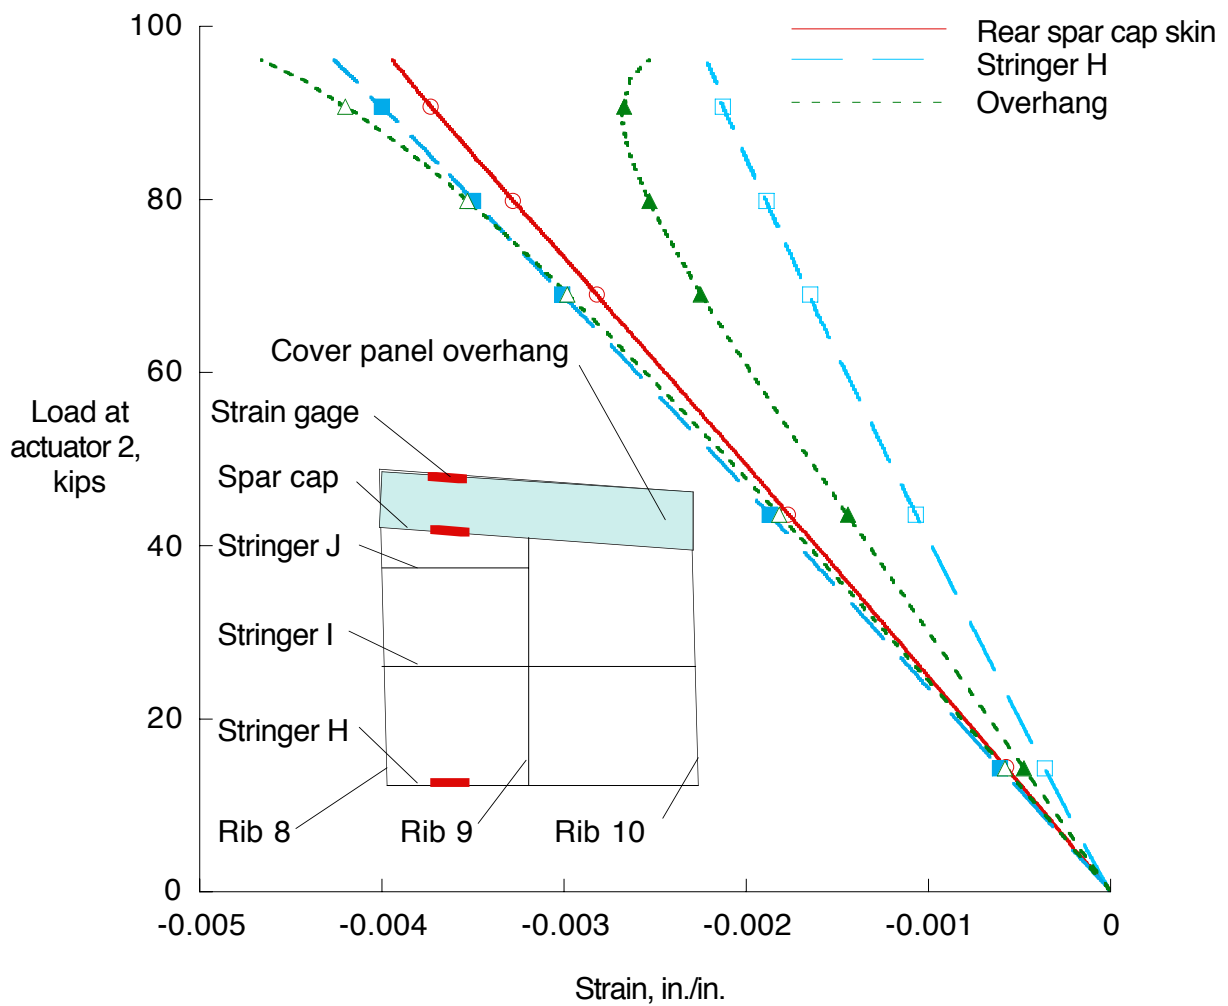
In addition to the global bending behavior illustrated in figure 50, local nonlinear behavior occurred in the upper cover panel to the rear of the rear spar between ribs 8 and 10. An overhang of the cover panel with a width of approximately four inches behind the rear spar left an unsupported edge along the length of the test article. This region is shown on figure 7 as the “critical overhang region.” Two back-to-back gages on the skin at the edge of the overhang midway between ribs 8 and 9 indicate that significant local bending occurred. Strains in the upper cover near the rear spar between ribs 8 and 9 are shown in figure 80 for the repaired structure. Open symbols represent strains on the upper skin surface on the cover panel. Filled symbols represent strains on the blade of stringer H and on the lower skin surface of the overhang. For a load less than 70 kips in actuator 2, the local bending effects do not occur (only the global bending effects are seen). However strain reversal is seen in the gages located in the overhang region as load approaches DUL. No other gages were in the overhang region.

Figure 80. Strains in cover panel overhang region behind rear spar.

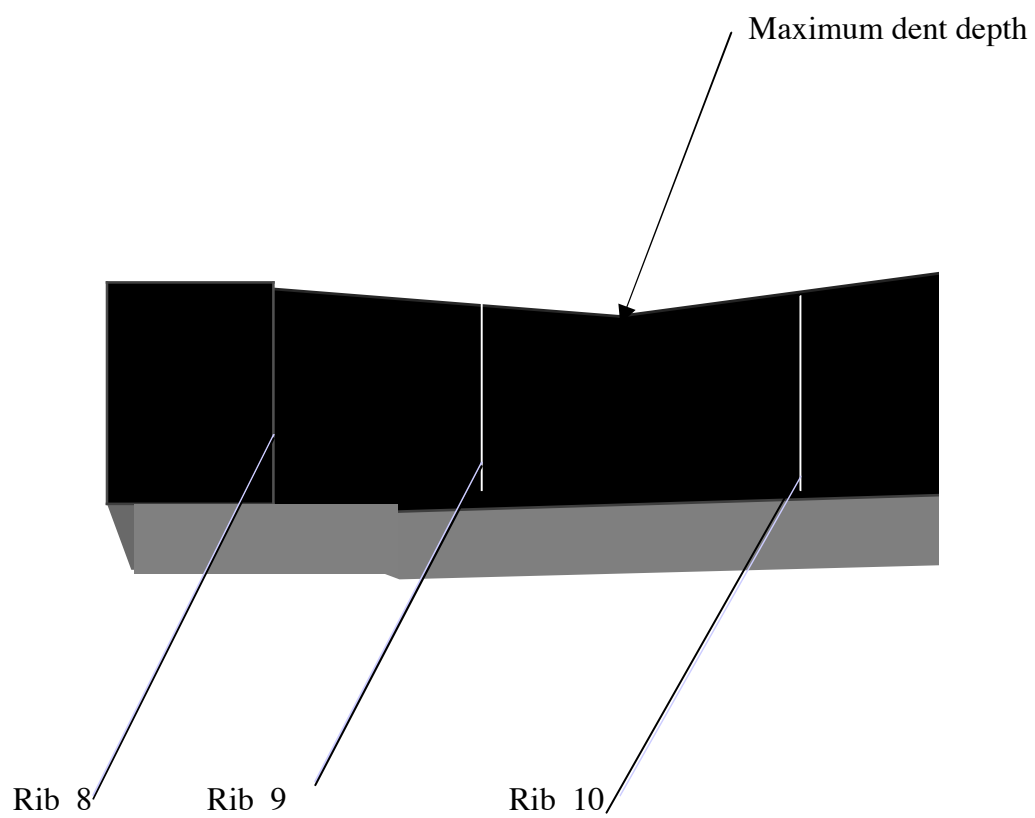
A small initial geometric imperfection in the form of a kink in the upper cover panel was present in the manufactured structure. This kink is centered half way between ribs 9 and 10 and has a maximum depth of 0.1 inches. A sketch of this kink is shown in figure 81. The kink was initially deemed minor enough to have no influence on structural behavior. However, since the kink is in close proximity to a stringer runout and in the region of the upper cover panel which displays local nonlinear behavior in the final test, the possibility that the kink influenced the behavior of the overhang region must be acknowledged. Since only two strain gages were in this region, there is not enough experimental data to explain fully the influence of the kink and the interaction of all components in this region. A detailed finite element analysis which accounts for this imperfection is needed for that. That analysis is beyond the scope of the present paper.

Figure 81. Imperfection in rear of upper cover panel.
